## **Pipeline Group Factual Report**

#### **Stork Draft HA-DM 12" Joints Exam plus Inspection Data**

Report No. 0270-07-17309

Testing and Examination of Pipe from  
Dixie Pipeline Company's  
12-inch Hattiesburg, MS to Demopolis, AL Pipeline

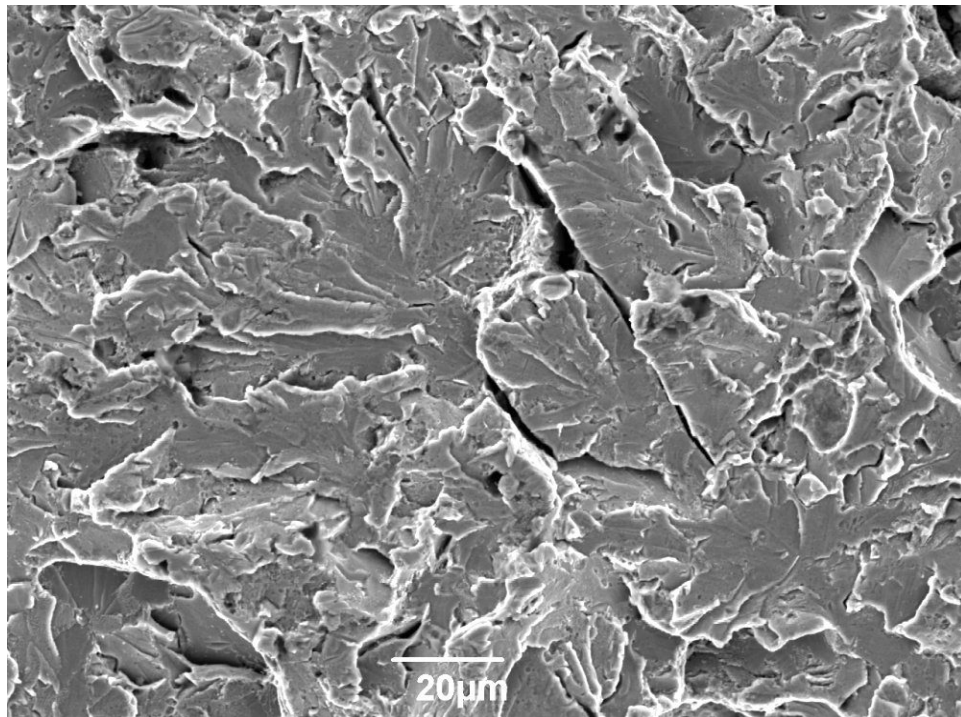
Figure 110 shows the area in the box at top and Figure 111 shows the area in the lower box in Figure 109 at higher magnification.

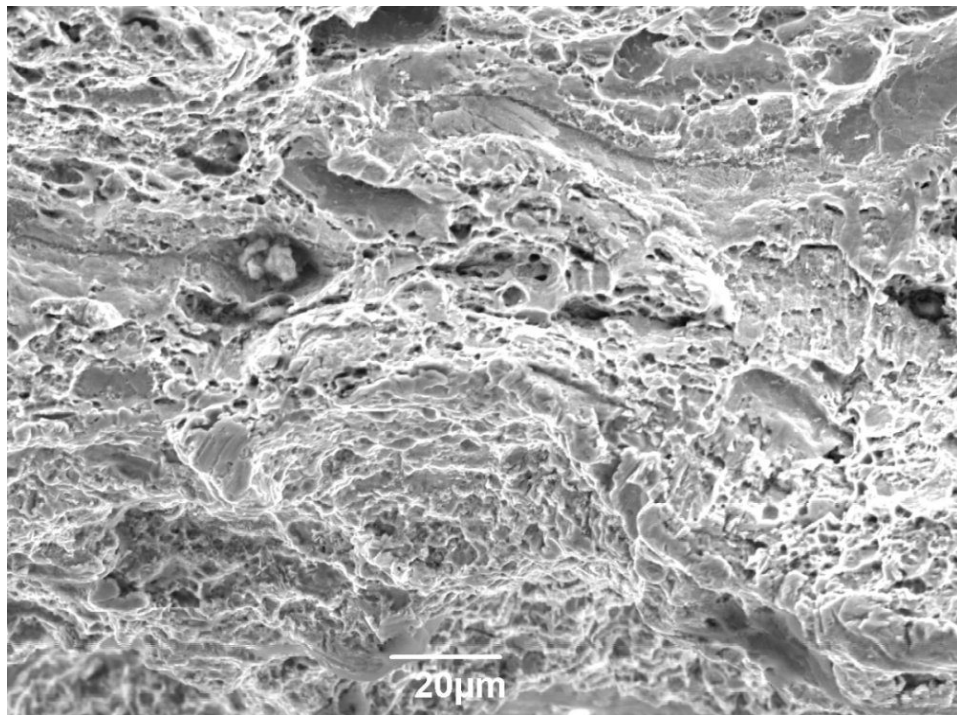
Figure 113 shows the area in the box at top, and Figure 114 shows the area in the box at bottom in Figure 112.

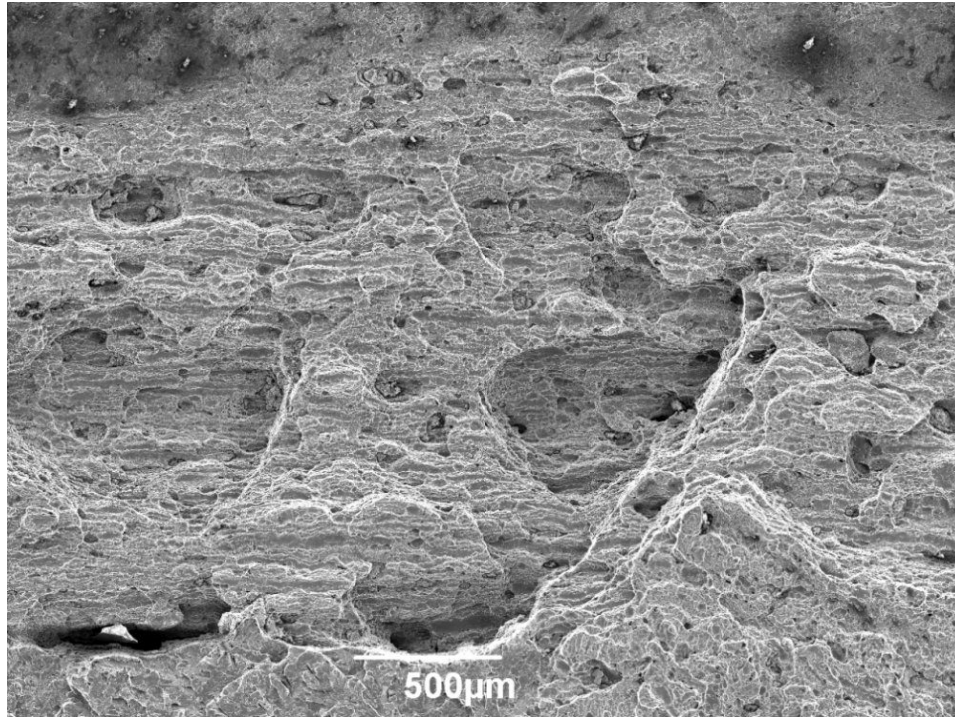
Figure 114

The appearance of the hook crack at top in Figure 136 was similar to that of the hook crack shown in Figure 114.

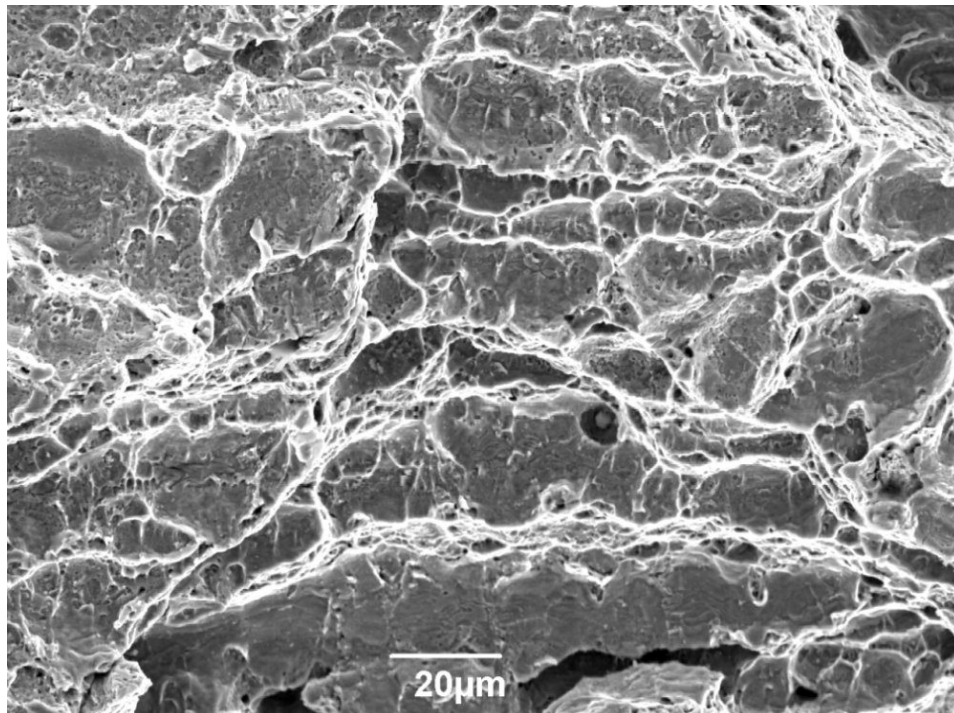
Figure 115 shows a large area of woody fracture, and Figure 116 shows a typical location at higher magnification.

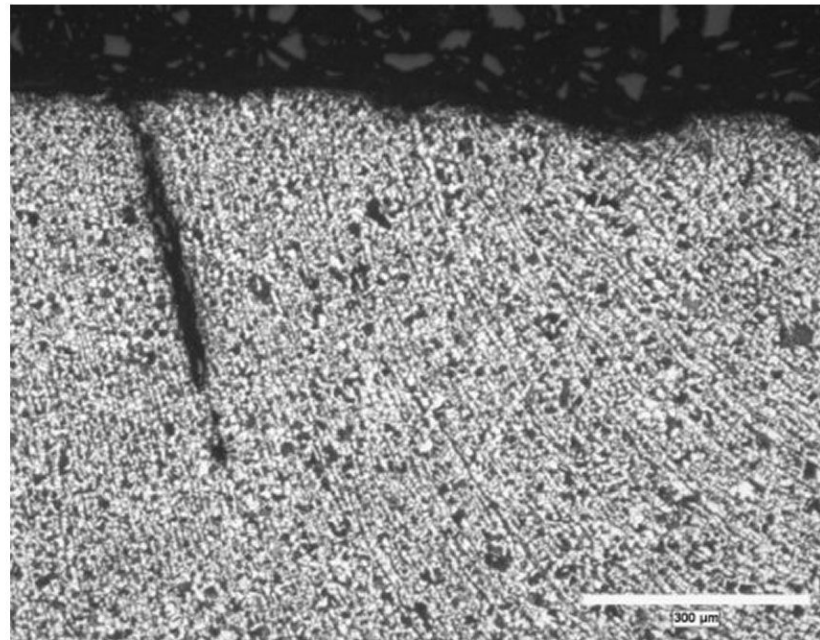
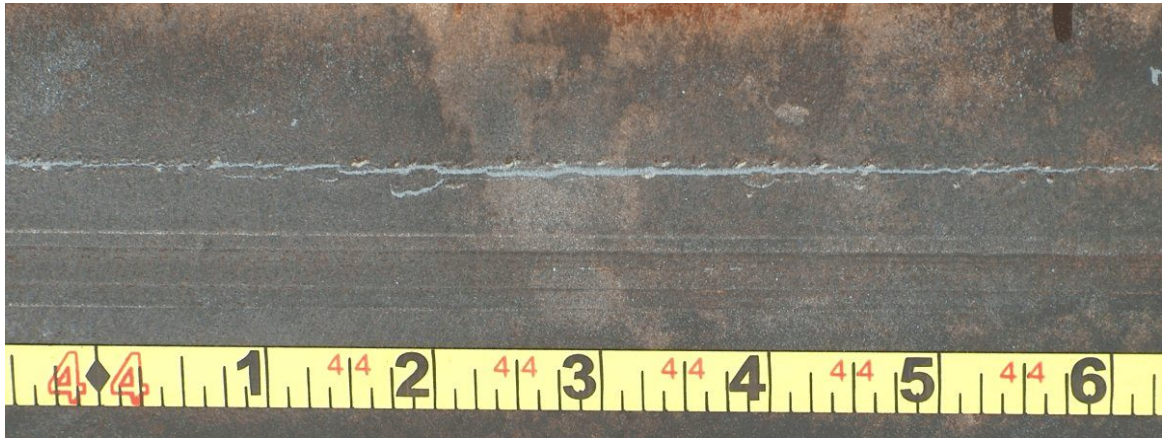
Views at two magnifications of a transverse section across one of the magnetic particle indications shown in Figure 121.

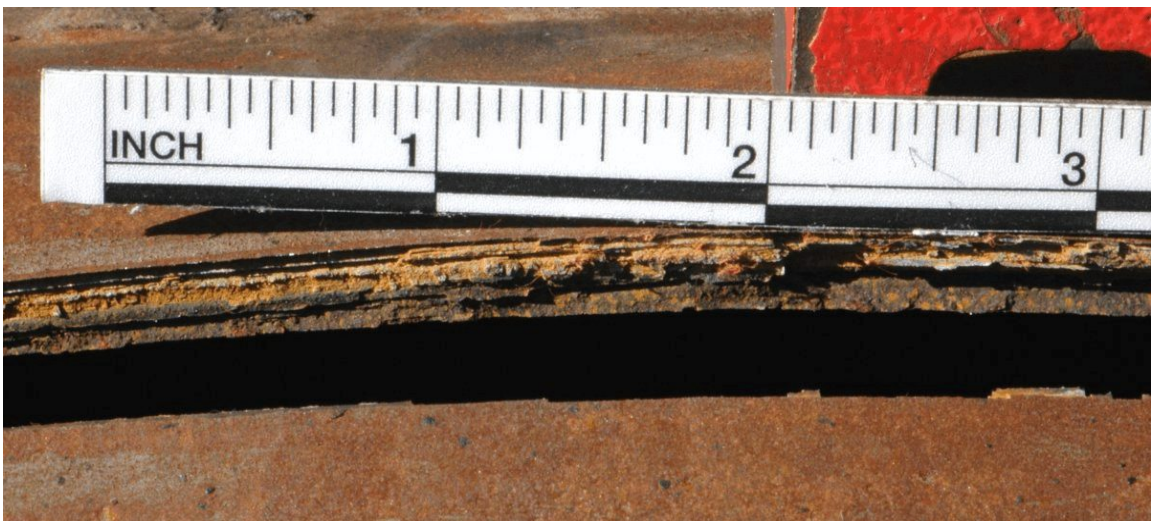
Figure 127

The fatigue-test rupture in Joint No. 10737 was 3 feet, 8 inches long, and extended from 46 feet, 8 inches to 50 feet, 4 inches, which was not a location with reported inspection indications. Figures 126 through 128 (provided by SES) show the fracture immediately after testing. Note that the downstream end is at left in Figures 126 through 128. The appearance of the fracture surface indicated that the failure started at large hook cracks.

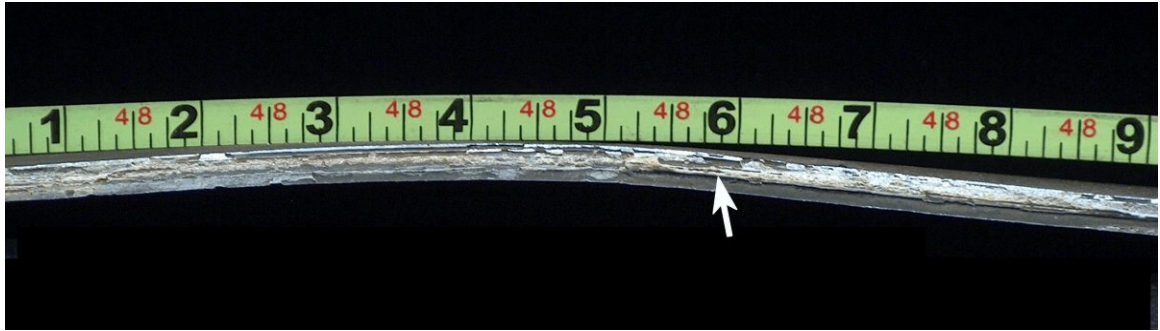
Photograph of the fatigue fracture in Joint No. 10737, with the upstream end at right.

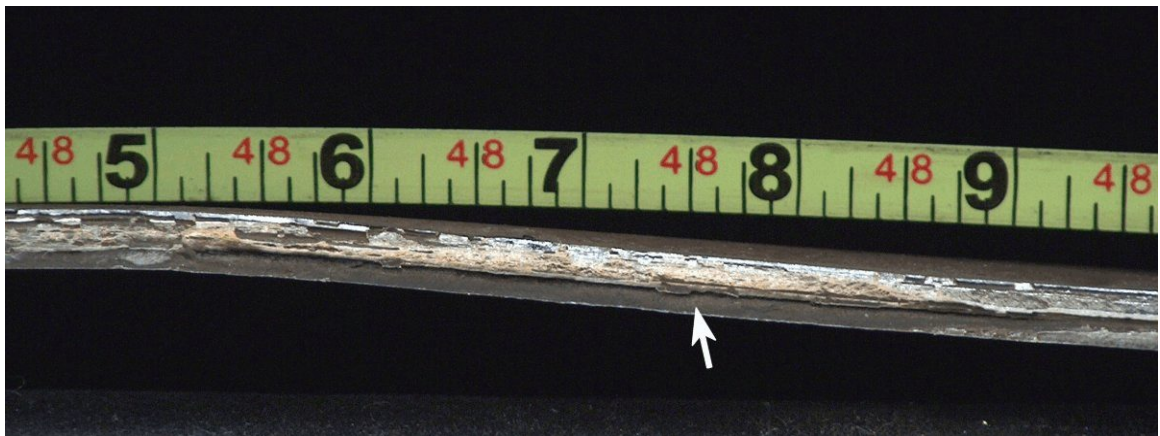
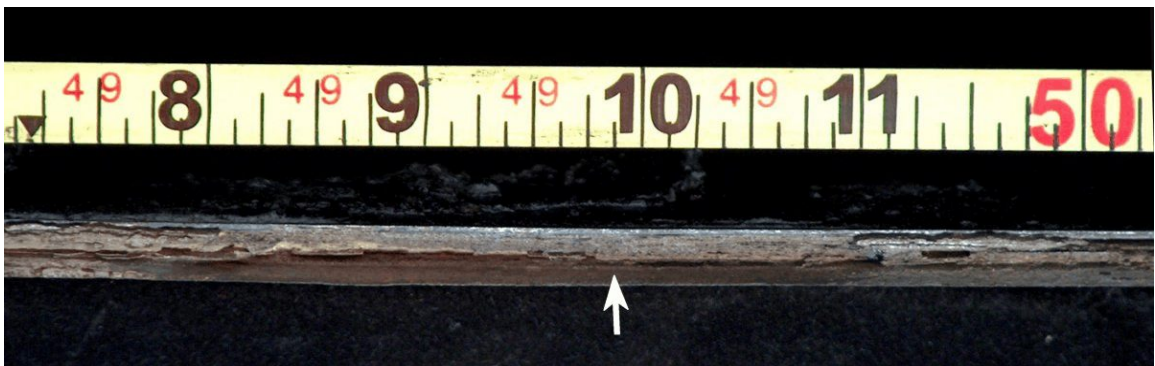
We cut the fractures from the pipe, cleaned them and examined them visually. The failure appeared to have originated near the middle of the rupture at a large hook crack on the inside surface that was continuous for almost the full length of the rupture. Figures 130 and 131 show part of the hook crack near the middle of the rupture, and Figure 132 shows the hook crack near the downstream end. The hook crack was 0.07 inch deep, or 24 percent of the wall thickness near the middle of the rupture, and 0.11 inch deep, or 41 percent of the wall thickness at the location shown in Figure 132. The fracture appearance toward the outside surface was indicative of smaller hook cracks.

Two views of the hook crack, arrows, near the middle of the rupture.

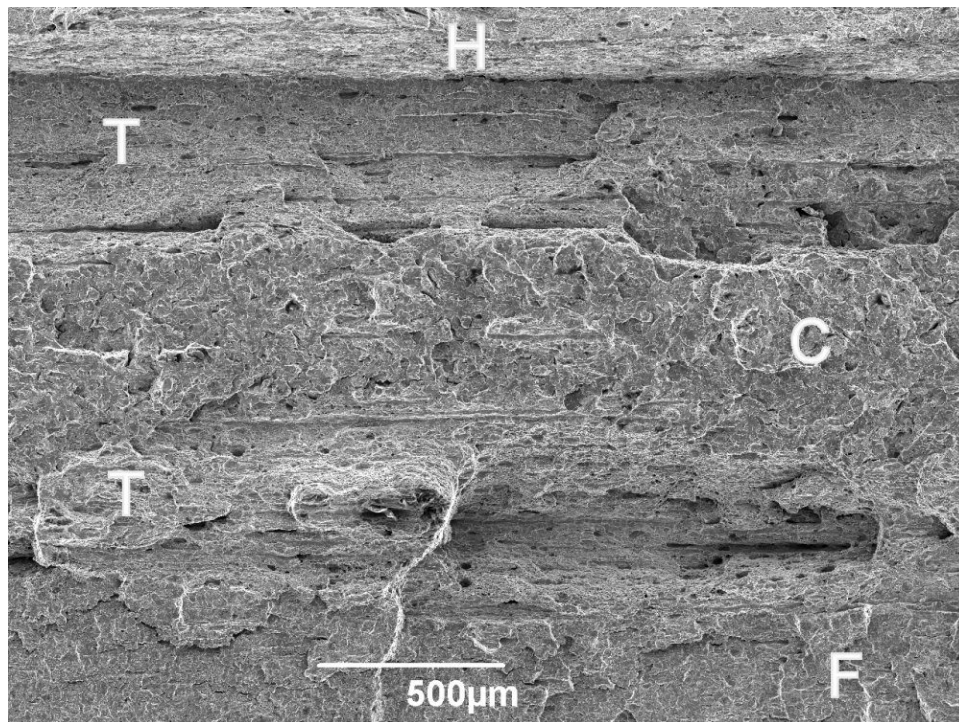
We examined the fracture surface carefully for evidence of fatigue. Two areas of bright, flat fractures with possible fatigue indications were found and examined in an SEM. Bright surfaces are indicative of relatively fresh fractures, as opposed to dark areas that represent prior flaws. The first area was found to be all cleavage fracture. The second area showed a narrow band within the area of bright fracture with steps across the fracture surface that were suggestive of fatigue. Figures 133 and 134 show part of the second area, which was centered at 48 feet, 9 inches, with arrows indicating the bright band with possible fatigue markings. Figure 135 shows the fracture at higher magnification; the fresh fracture does not appear bright because the micrograph was taken in the SEM. The longitudinal lines within the band indicated by the arrows were not seen elsewhere on the fracture.

Electron micrograph with arrows indicating the band with possible fatigue markings.

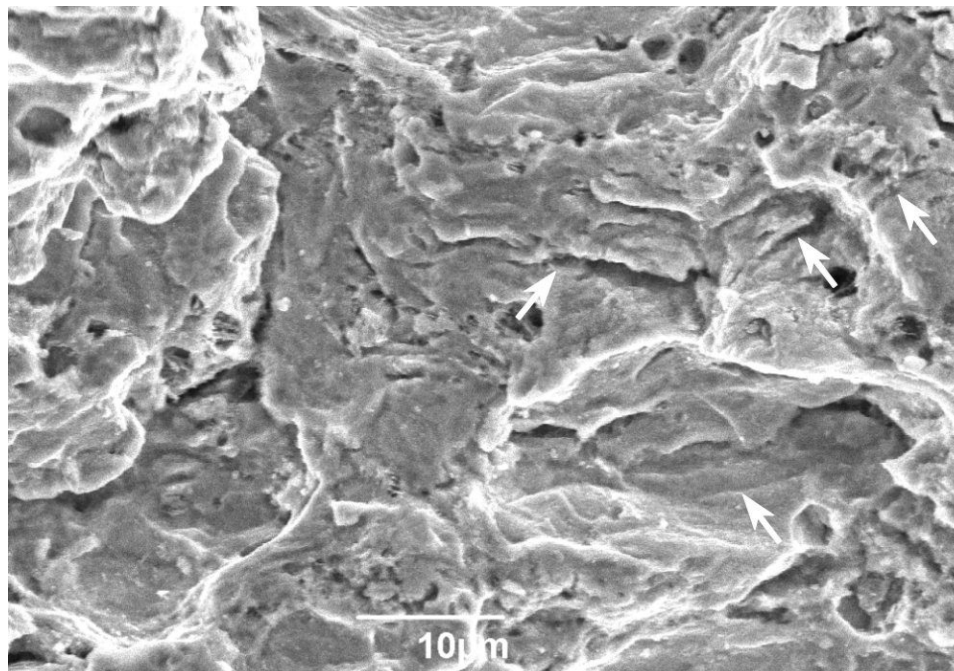
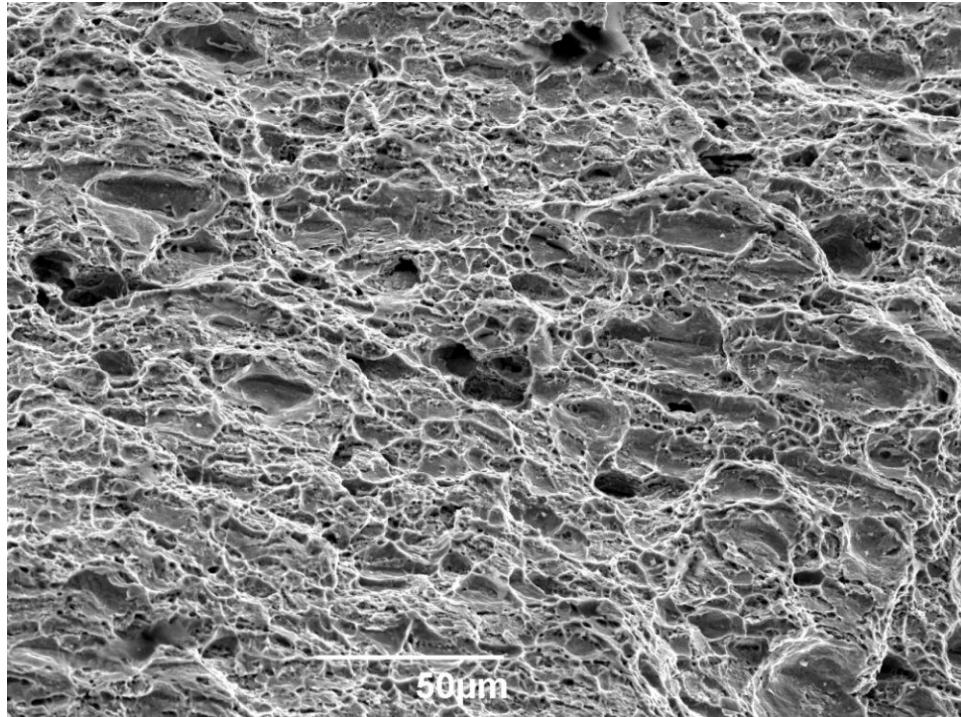
Views at high magnification of fatigue indications, some of which are indicated by arrows, at two locations within the band indicated by the arrows in Figure 135.

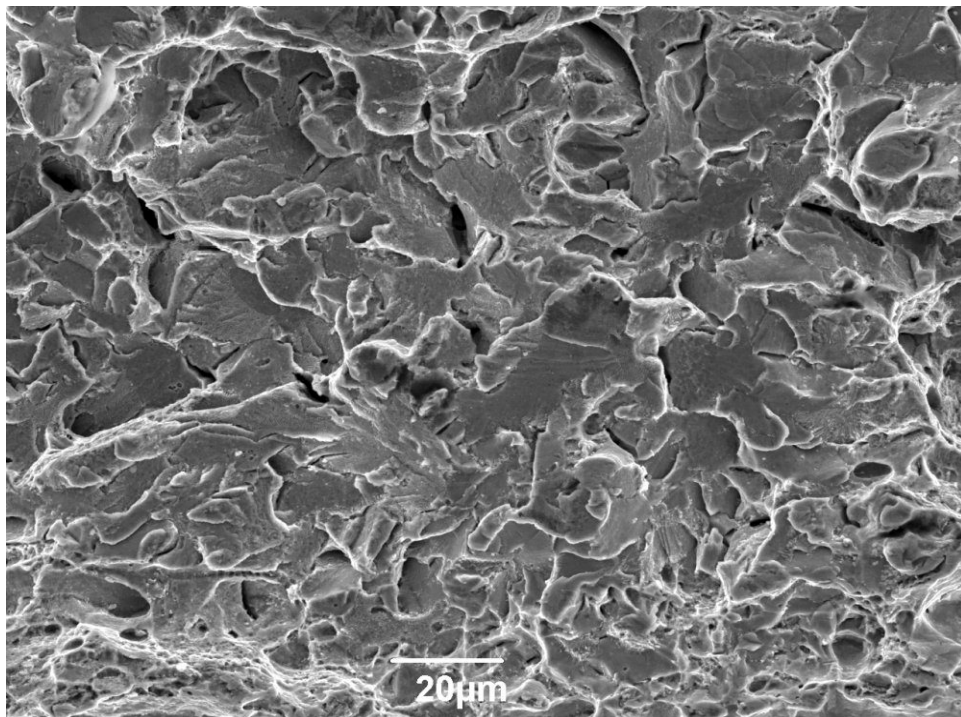
Figure 139

Figures 139 and 140 show representative areas of tearing and cleavage, respectively.

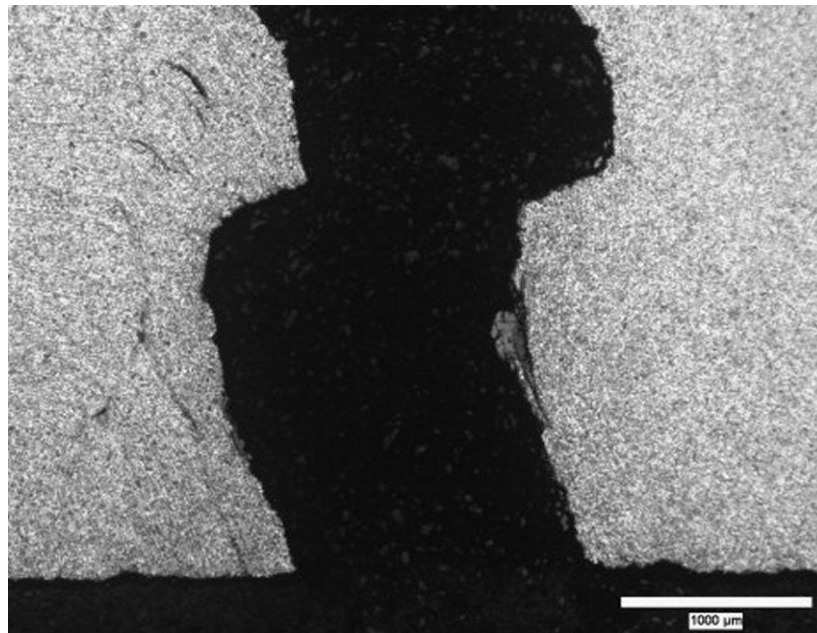
Figure 141      Joint No. 10737      8X  
Nital Etch

Matching transverse sections were taken from each side of the fracture at the location shown in Figure 134, and prepared for metallographic examination. Figure 141 show the sections after polishing and etching, with a large hook crack evident at the inside surface, smaller hook cracks at the outside surface and flat fracture in between. Figures 142 through 144 show the large hook crack at the inside surface at higher magnifications. There was scale along the surface of the hook crack, indicating it originated during manufacture of the pipe. As shown in Figure 143, the fiber lines on one side of the weld were very irregular, which is indicative of offset skelp edges during manufacture.

Matching transverse sections from the middle of the fracture shown in Figure 134.

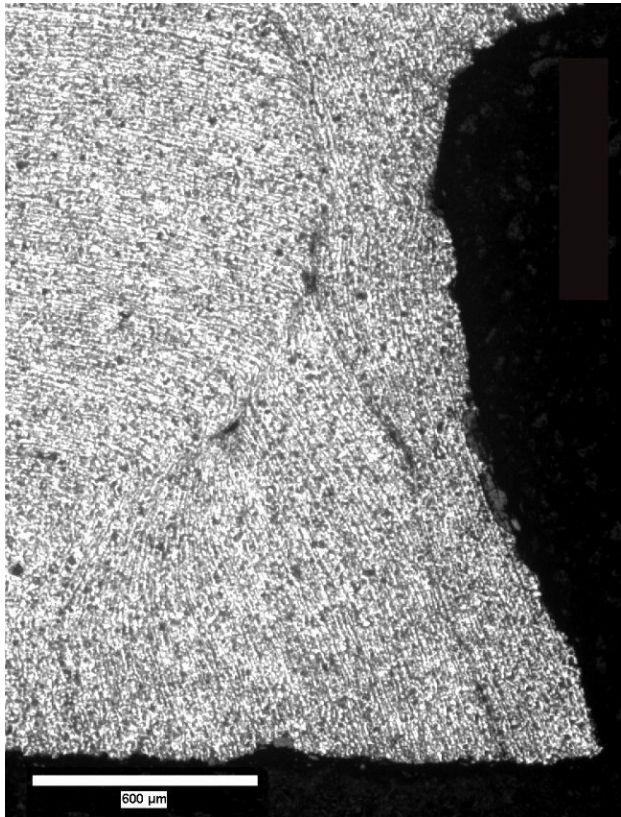
Figure 142      Joint No. 10737      25X  
Nital Etch

View of the hook crack at the inside surface.

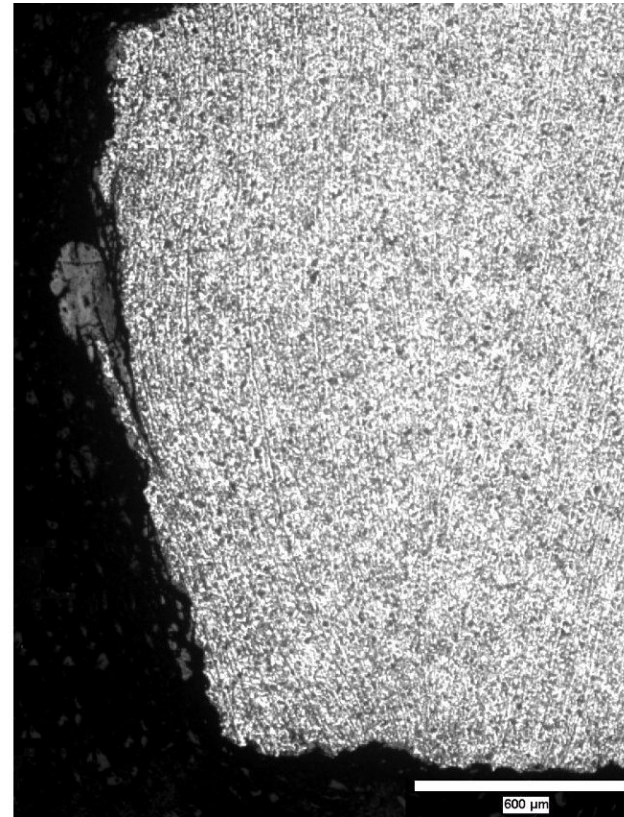
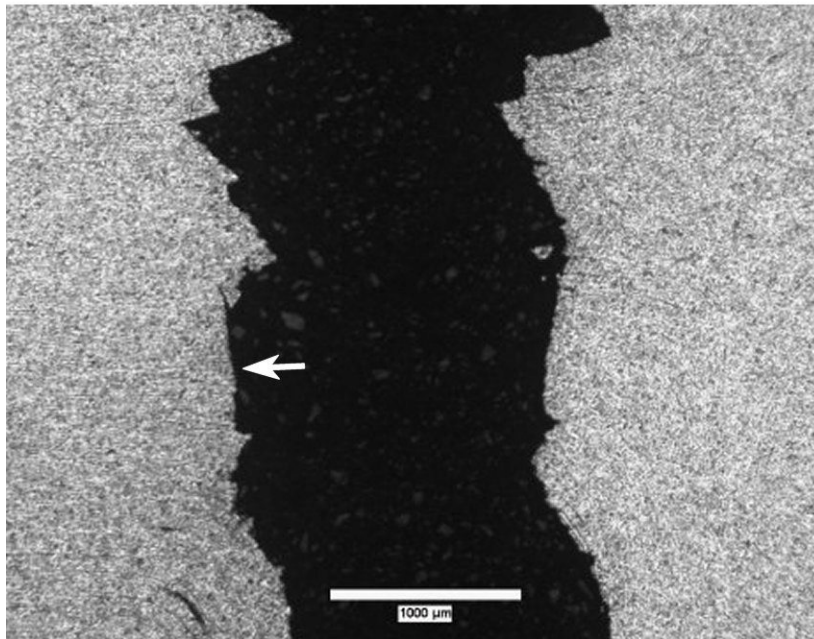
Views of the hook crack at higher magnification. Note the irregular fiber lines in Figure 143.

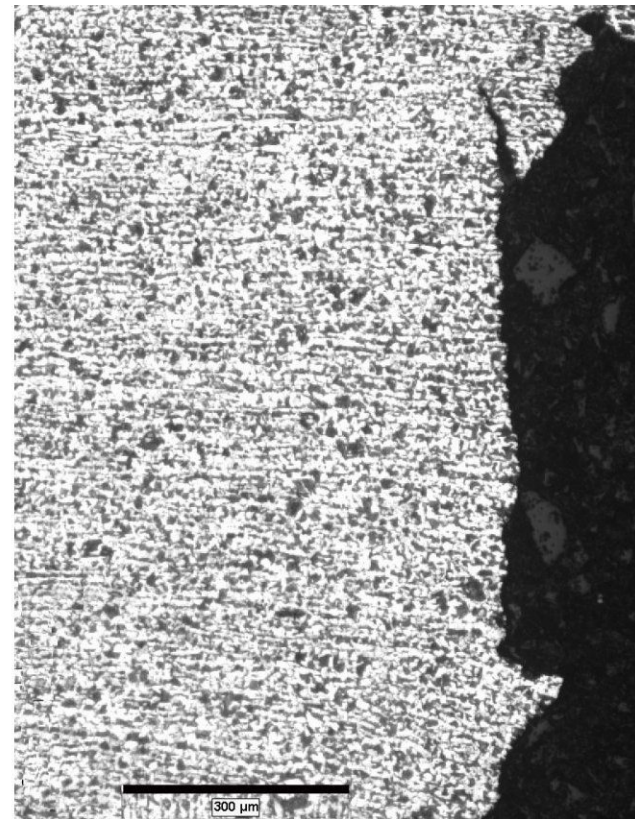
Figure 145      Joint No. 10737      25X  
Nital Etch

Figure 145 shows the fracture near midwall, which includes the flat area that was examined in the SEM, arrow, and Figure 146 shows the flat area at higher magnification. The flat, straight fracture is consistent with, but not necessarily indicative of, fatigue.

Figure 145 shows the fracture near midwall with an arrow indicating the flat fracture examined in the SEM, and Figure 146 shows the flat fracture at higher magnification.

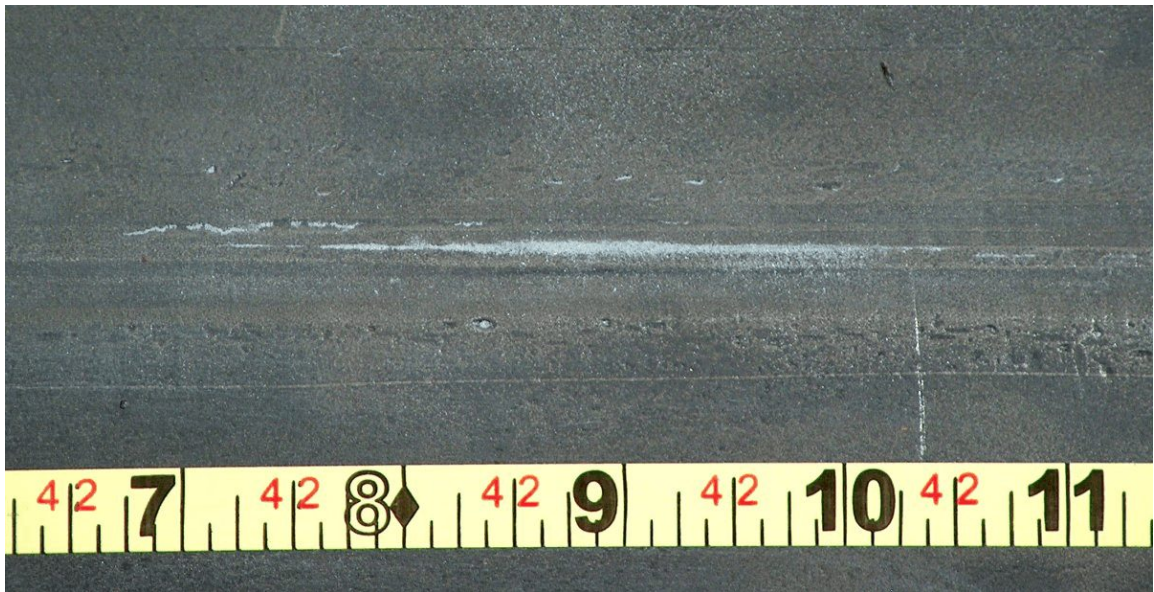
The reported Manual and PAUT inspection indications were downstream of the rupture, and were covered with Polyguard wrap. The wrap was removed and the weld at those locations was inspected with magnetic particles. We found a number of straight, discontinuous indications similar to those shown in Figure 111. Figure 147 shows a location with the heaviest magnetic particle build up, which is shown in closer view in Figure 148. A section for metallographic examination was taken from the location of heaviest particle build-up. As shown in Figure 149, the indication was caused by a hook crack that was approximately 0.02 inch deep. There was no evidence of fatigue crack extension from the hook crack.

Figure 147 shows magnetic particle indications along the fatigue-test section of Joint 1037 down stream from the rupture, and Figure 148 shows the heaviest magnetic particle build up.

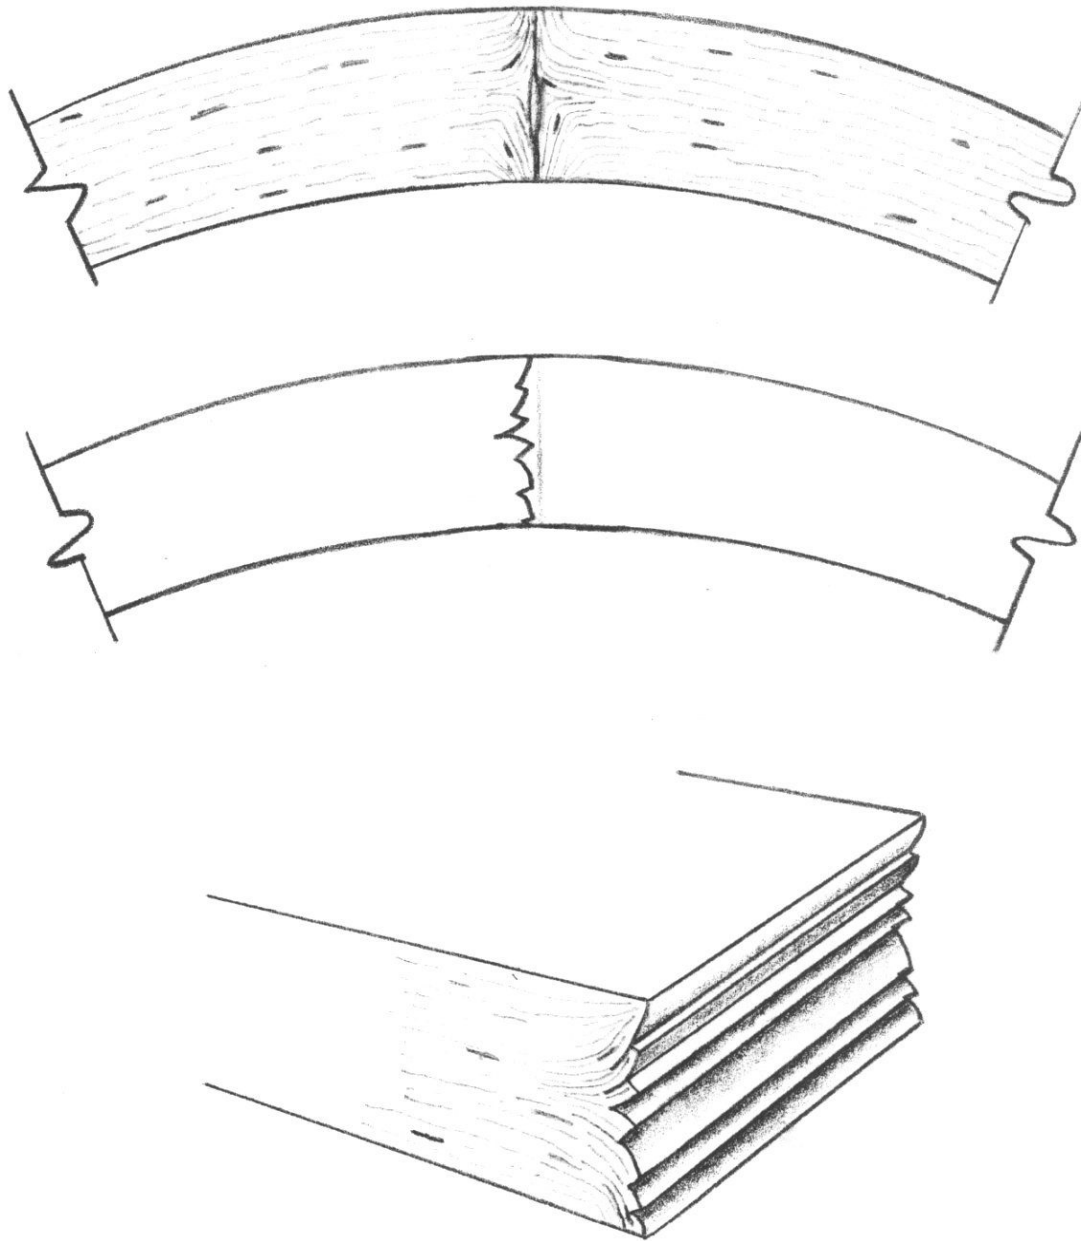
Figure 152

One of the most common flaws in older electric-resistance welded pipe, and the most common found in the 21 test joints, are hook cracks. When the abutting edges are brought together, the fiber lines in the skelp are bent toward the outside and inside surfaces, as illustrated in Figure 152. The change in direction at the weld creates a weak plane, similar to the z direction in the skelp. The properties in this plane depend on the amount of segregation and, particularly, the number and size of nonmetallic inclusions in the steel. Depending on the properties of the skelp, how the pipe is formed, how the skelp edges are prepared and other factors, separations may develop along the up-turned and down-turned fibers during manufacture. In addition, separations may develop along the fiber lines from the stress caused by internal pressure. In either case, the separations are called hook cracks. Scale from the heat of welding can sometimes be found on the surface of hook cracks, which shows they formed during manufacture. Often, however, no scale is apparent, and it is not clear whether the hook crack formed during manufacture or subsequently due to stress across weak fiber lines.

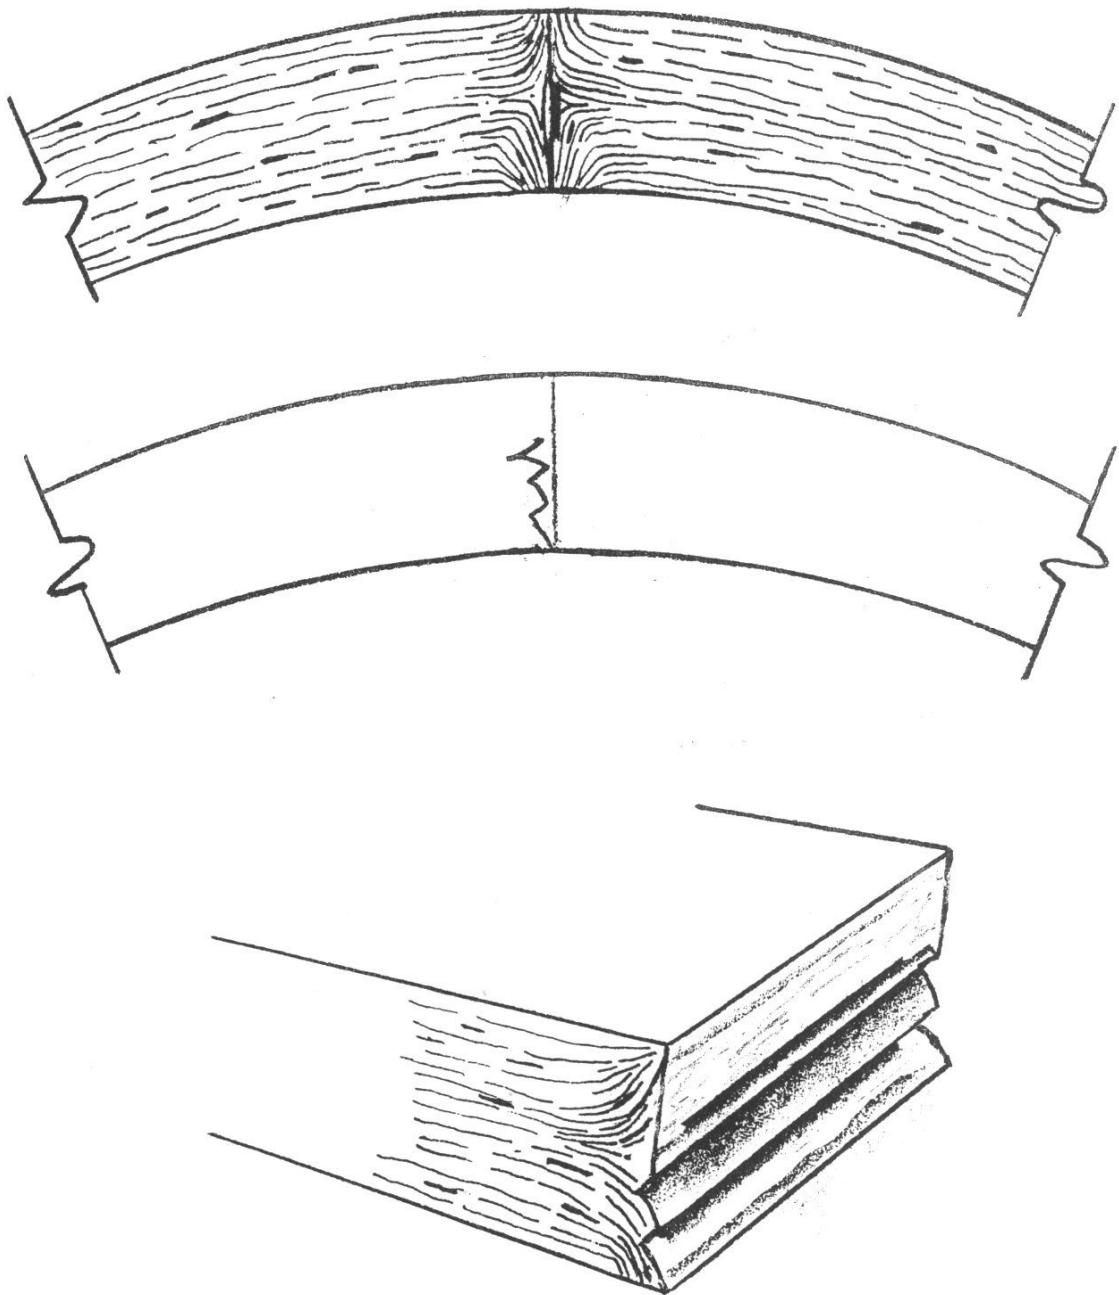
Hook cracks are identifiable on fracture surfaces because of the curved separations. Figure 153 illustrates a fracture surface with hook cracks across the wall, and Figure 154 illustrates a fracture with partial hook cracks.
